D-18791

**JPL Technical Infrastructure Program
Commercial Off-The-Shelf (COTS) Parts**

Plastic Parts Delamination Validation Using Failure Analysis Methods

March 6, 1998

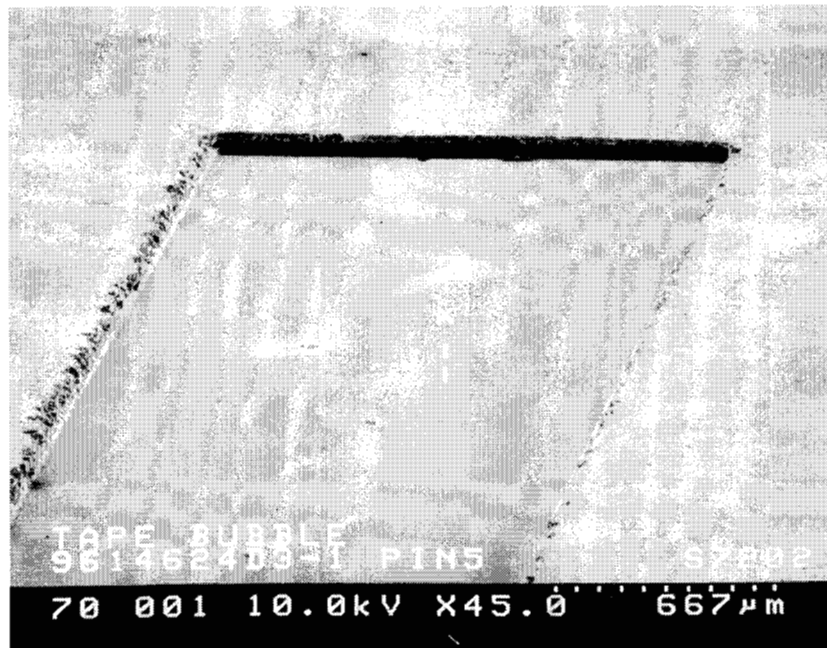
The "Top Side" C-SAM™ image indicated voids at pins 12, 21 and 28 and around the die. Sanding through showed that there are thin strips of "Mylar" tape across the package from pin 5 to pin 28 and from pin 12 to pin 21 embedded in the package and stuck to the lead frame. Sanding the plastic thin and then peeling the tape off showed air bubbles in the tape at the locations indicated by C-SAM™. See Figures 1 and 2 for Scanning Electron Microscope(SEM) views of the bubbles in the tape. The voiding around the die was not verified due to an initial lack of understanding of the CSAM™ images. Subsequent analysis of part D3-2 showed that the package material did not adhere to the exposed die heat sink material. It is assumed that D3-1 had the same situation but was missed because the assumption was that the voiding seen in the C-SAM™ was at the top of the die surface in the package material and was not found during sanding. Subsequent discussions with Sonoscan Inc. indicated that the voids would be at the die attach level and with that in mind, sample D3-2 was very carefully sanded and the void verified. See below for details of the procedure on D3-2.

Figure 1. The arrow indicates the bubble in the "Mylar" tape of sample D3-1 near pin 5 in this SEM image.

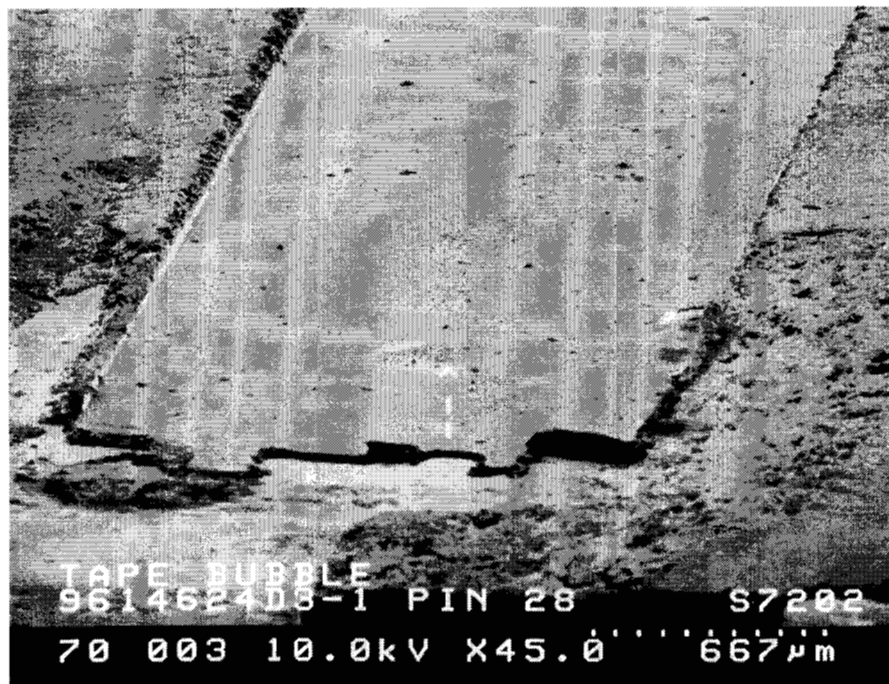
Figure 2. The arrow points to another tape bubble on D3-1 near pin 28.

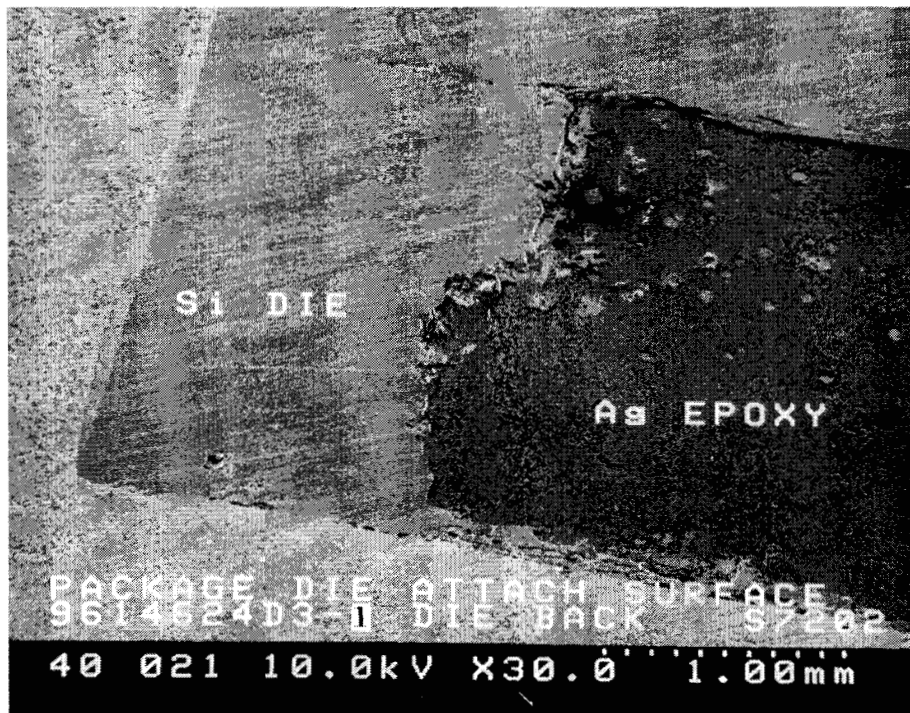
The "Die Attach" C-SAM™ image indicated that there was about 90% voiding in the die attach. After sanding through the die until the silicon was very thin, the remaining thin silicon puckered indicating that it was not attached. Poking at the silicon with the point of a sharp knife broke off flakes ("slabs") of silicon verifying that the die was not adhering to the die attach material. See Figures 3 and 4 for a SEM view of the die attach area. The die attach material is a silver filled epoxy and a few small pieces (flakes) remained on the silicon. After documenting the poor die attach, further sanding was done into the heat sink and no other voids were found. The remaining heat sink was lifted out of the package and no voids were found under it.

Figure 3. This SEM view is of sample D3-1 and shows the sanded package with a thin layer of the silicon die and the exposed die attach silver filled epoxy.

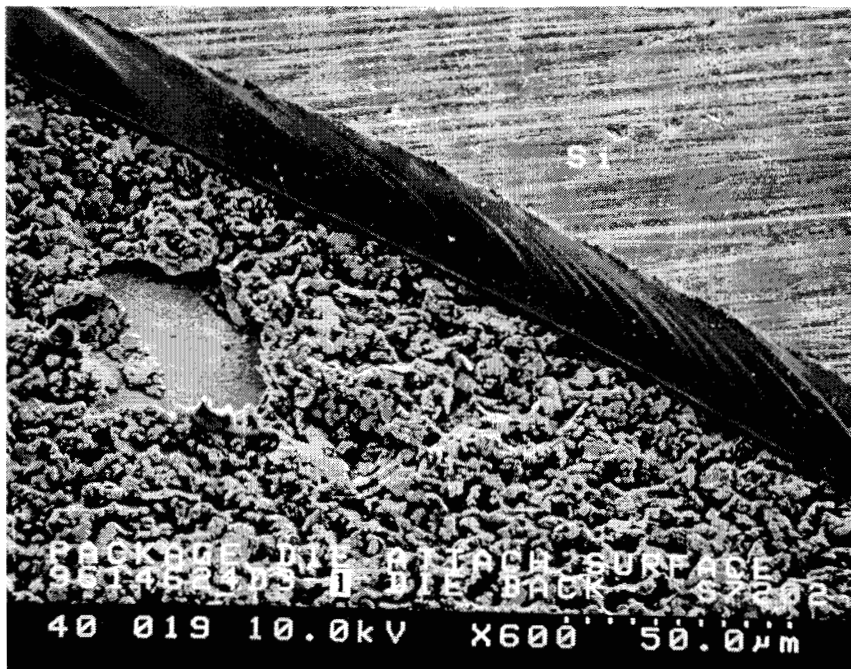
Figure 4. A close-up view of the remaining silicon wafer and die attach material of D3-1. Note that the die attach material surface is very much intact due to non-adhesion to the silicon die. Also note that die attach material is missing from the heat sink surface.

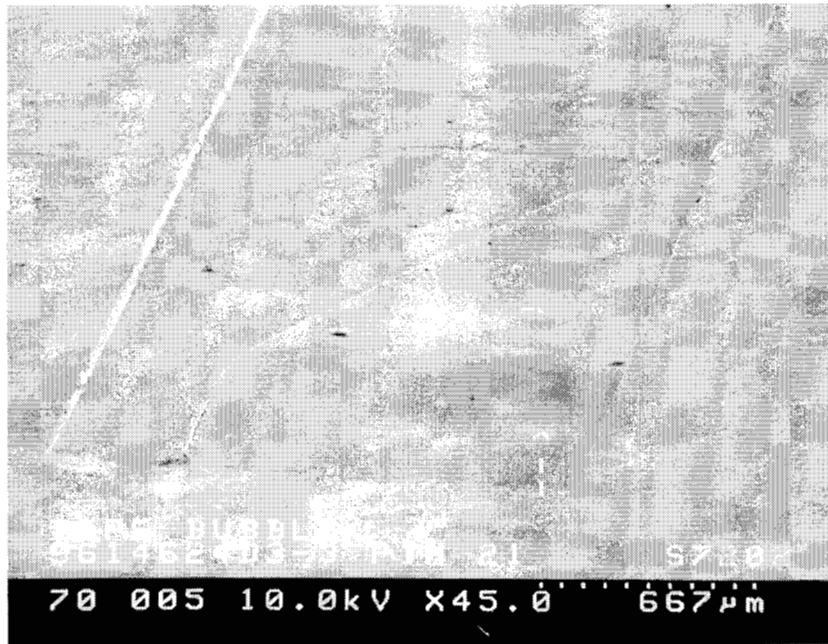
The "Top Side" C-SAM™ image indicated similar voiding near pins 5, 12 and 28, voiding around the die and slight voids at the egress of leads 17, 18, 19 and 20. Sanding as in D3-1 and D3-2 showed that this part also had voids under the "Mylar" tape at the areas indicated in the C-SAM™ image. See Figure 7 for SEM image of bubble near pin 21. Because the plastic was thinned at the lead egress, careful picking with a sharp knife point at the lead egress of pins 17-20 flaked small pieces of the plastic away. This indicates poor or no adhesion of the plastic to the lead material. Again verifying the results of the C-SAM™ image. The voids at the die attach level were not investigated because this part was subjected to hot fuming Nitric Acid to expose the die surface to test for corrosion of the metallization. See the discussion below for information on the corrosion tests.

Figure 7. This SEM view is of the "Mylar" tape bubble of Sample D3-3 near pin 21.

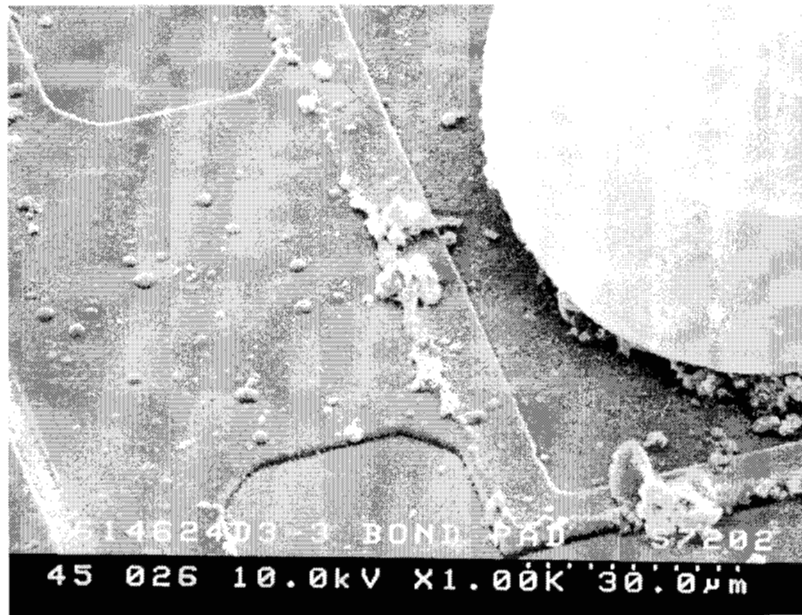
D3-3 was used to check for corrosion on the die surface. The die surface was exposed using a special piece of equipment that subjects the part to hot Fuming Nitric acid through a mask. The mask tends to limit the area that is treated. However, there is some undercutting. The acid attacks the plastic and the copper leads, but not the silicon die, aluminum metallization and the gold leads. Since the die is passivated, the aluminum metallization that is exposed is only around the die bond pads. A careful examination with the SEM did not indicate anything that could be related to corrosion. See Figure 8 for SEM image of typical die bond pad following passivation removal.

Figure 8. A SEM view at 1000x of a typical die bonding area of Sample D3-3 after passivation removal. The small particles are debris left over from sample preparation.

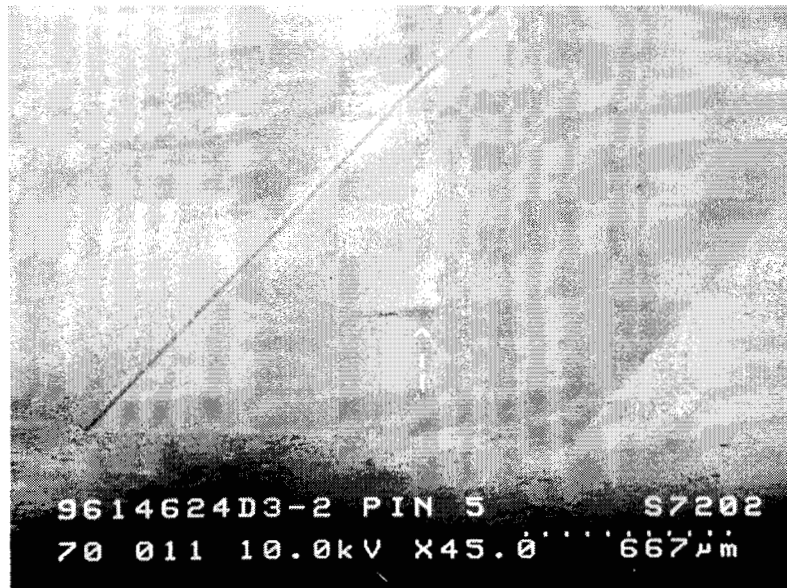
The "Top Side" C-SAM™ image indicated slight voiding near pins 5, 12, 21 and 28 and at the end of the die near pins 10 and 23. Sanding through the package from the top in a similar fashion as D3-1, verified similar voids in the "Mylar" tape of D3-2 as was found in D3-1. See Figure 5 for SEM view of the bubble near pin 5. Further careful sanding with very fine grit paper thinned the plastic until it was noted that at the pin 10 and 23 end of the die, the remaining thin layer of plastic would move when touched with the tip of a sharp knife blade. Blowing on the thinned plastic with canned Dust-Off compressed gas with an extension nozzle lifted the thinned plastic off of the die heat sink. See Figure 6 for an optical image of the remaining die and the removed plastic package material. There was no evidence of adhesion of the plastic package material to the heat sink. The heat sink in this area is silver plated

Figure 5. SEM view of the bubble in the "Mylar" tape of D3-2 near pin 5.

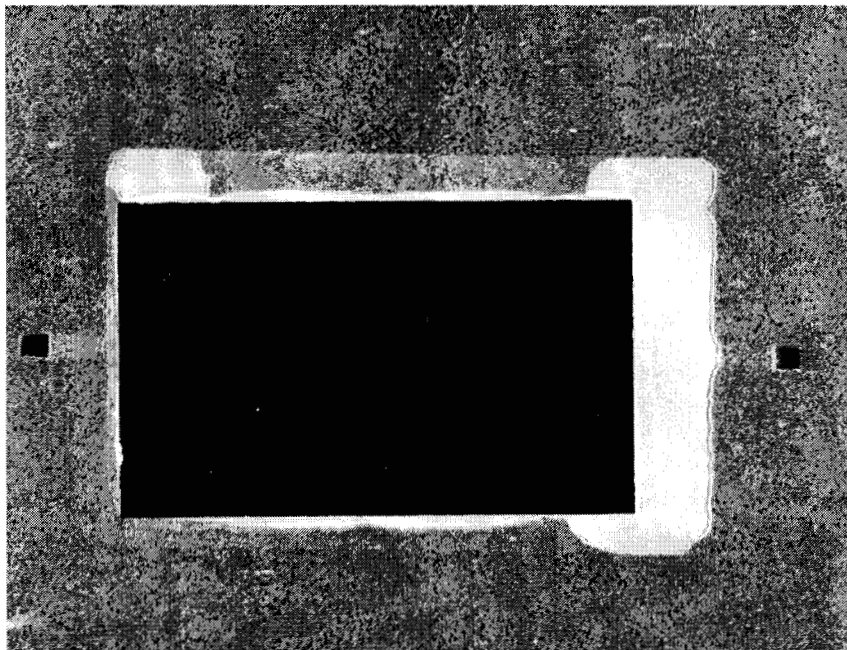
copper. The material that was blown off matches the area indicated in the C-SAM™ image.

Figure 6. Optical view of D3-2 after sanding until the die is very thin. Compressed gas blew away the thinned plastic package material. The large dark rectangle is the remaining die, the gray area is the package material and the light area is the exposed heat sink.
